DESIGN IMPROVEMENTS FOR GM VORTEC DISTRIBUTOR CAPS

Models Covered: 4000L, 2 4000S, 4000S-1P, 4000R, 2-4000S, 4000EHP
IS 18 7-17-09

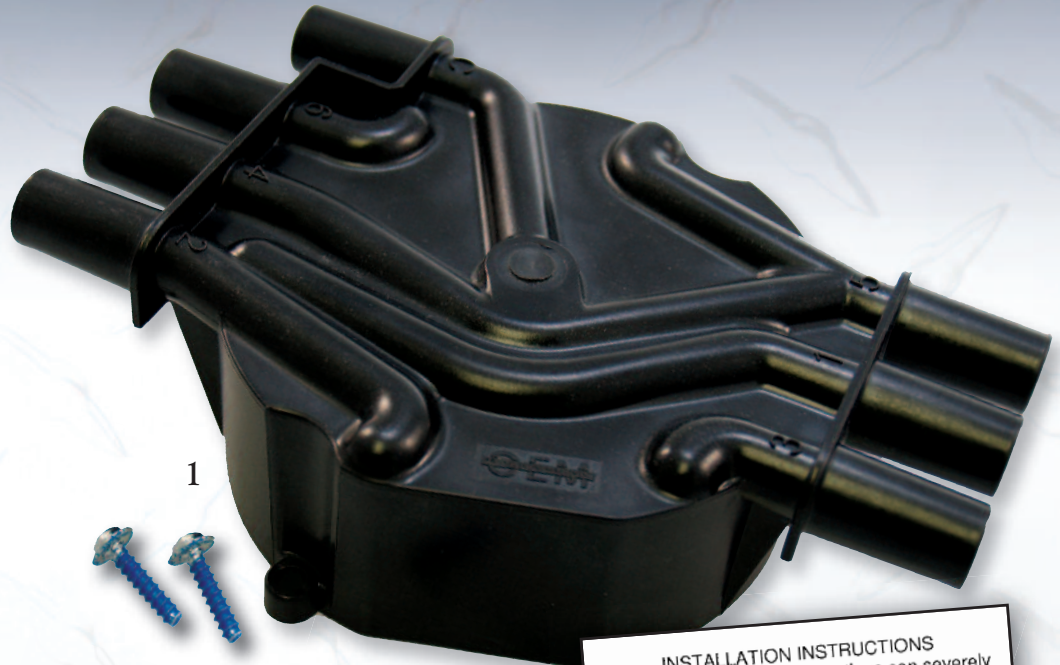
1. New Severe Duty 30% Glass reinforced polyethylene (PET) cap material offers superb resistance to moisture absorption and electrical arcing.
2. Included with every affected part number is an instruction sheet which outlines GM technical service bulletin (TSB) 03-06-04041, which references poor ventilation within the distributor as the root cause of failure. This TSB must be followed to insure a complete corrective repair.

3. Insulation around the tower contacts on underside of cap (common failure point due to arcing) is 2mm thicker than competitive designs.
4. Aluminum tower contacts are superior to brass in this particular application. This is due to the buildup of nitrogen oxides within the cap from high voltage discharge. These oxides combine with water vapor to form nitric acid. The nitric acid then combines with the copper present in brass to form corrosion on the contacts which may cause a misfire. Aluminum does not contain copper and has a better resistance to this type of corrosion.

5. Matching distributor rotor (OEM part #3961) features oversized air circulation blades to better disperse the harmful nitric acid vapors. In addition the rotor blade is coated for radio frequency interference (RFI) suppression and protection against corrosion.

- 1) Remove screens within distributor per OE TSB 03-06-04-041A to allow proper ventilation of distributor and eliminate possibility of failure due to internal moisture, corrosion, and subsequent arcing between terminals.
- 2) Ensure distributor cap mounting holes located on plastic body of distributor are free of old dried LOCTITE® originally applied to OEM mounting screws. Residual dried material can cause distributor mounting holes to split when new screws are installed.
