PRODUCT BULLETIN

Chrysler Ignition Coil Application Alert

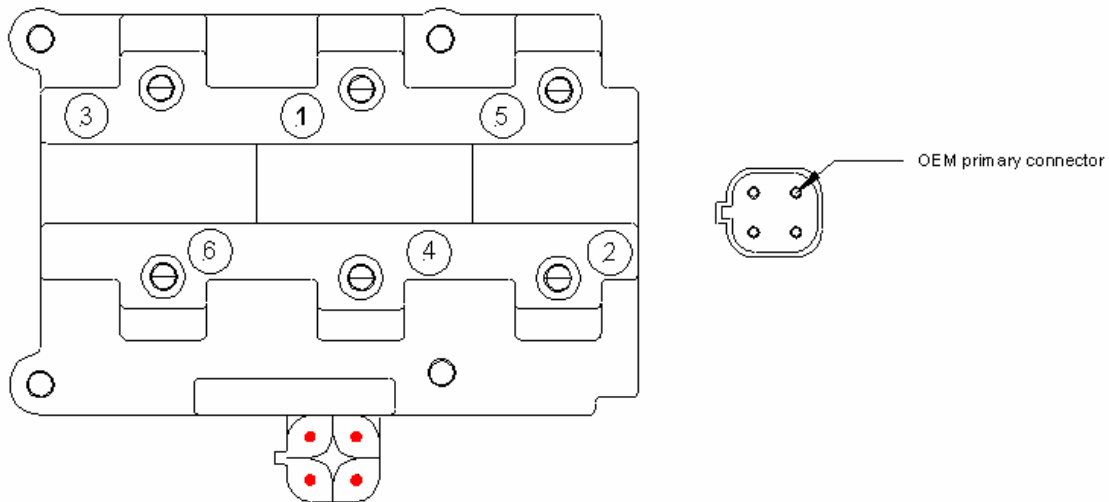
Some Chrysler vehicles may experience misfires, hesitation, and no-spark conditions due to corroded or loose primary coil wiring harness terminals as originally equipped. This replacement coil has slightly larger diameter connector pins to help remedy this situation. The test below MUST be performed to ensure electrical continuity of mating connectors.

Failure to perform the test above, can lead to loss of engine power, misfiring, engine cut-out, and possible loss of power to power brakes and steering while vehicle is in operation.

- 1) Inspect and clean OE wiring harness connector terminals with non-residual electrical contact cleaner.
- 2) Install coil and start engine. With engine running wiggle OE connector noting any changes in engine speed or complete cut-out.
- 3) If engine cuts out or any changes in speed are noted, OE connector should be replaced due to worn and oversized terminals. Terminals may be re-sized smaller to verify faulty electrical connection prior to primary connector replacement.
